# INSPECTION REPORT

REPORT NO.: TH121A2508

Supplier : Shenzhen YLD home appliances Limited

Production Description : Hand Blender  
Article / Model Number/Code : MHB100  
Declare Inspection Lot Size : 3072pieces (384cartons)  
Production Status : 91.6%(2816pieces) packed in export cartons  
Type of Inspection Performed : 1<sup>ST</sup>. Pre-Shipment Inspection  
Inspection Date : 2025-08-26  
Inspection Location : Dongguan of Guangdong

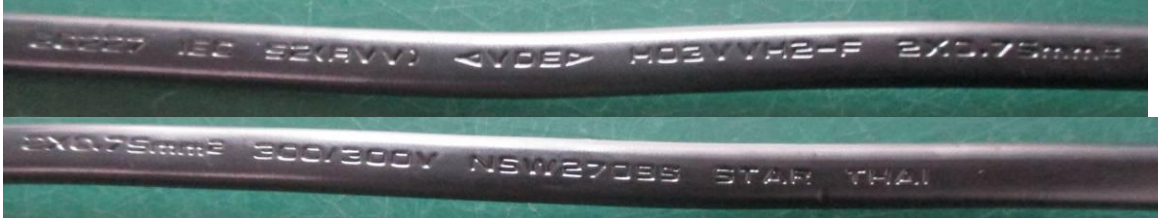
1. AC cord : 60227 IEC (52)RVV VDE H03VVH2-F 2X0.75MM2 300/300V  
NSW27095 STAR THAI.
2. AC Plug : HL-802 16A 250V~ STAR THAI.
3. Switch : HB SW-01.
4. Cap : MEX/TENTA MKP 0.68uF K X2 275VAC 40/100/21.  
JNC JN1-2M
5. Motor : DC-7812-L DC220-240V CLASS H.
6. IC : BT137 800E.
7. Fuse : 392 T3.15A 250V.
8. Varistor : HEL7D471K
9. PCB mark : KB-3151S 94V-0; TB2026-LED.
10. Barcode No : "6005519093189" On gift box, "0116005519093186" on outer carton.
11. Batch code : "PO110791" On rating label / gift box/outer carton.

| <p>23. AC cable mark</p> | |

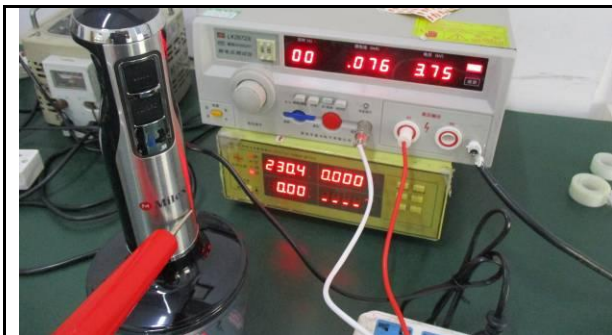
Checking Criteria : 3750 Vac for 2 seconds at 0.5 mA  
Sample Size : 125pieces

62. Hi-Pot test OK

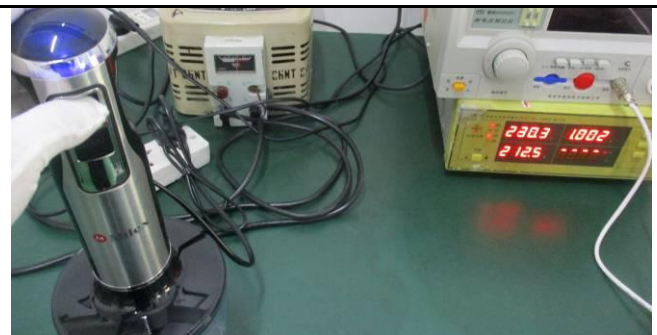
Type of tester : PH9901  
Valid date : 2026-08-22  
Checking Criteria : +15% tolerance of the rated power 800W at the highest setting  
Sample Size : 125pieces  
Result : 185-236W (without load)  
TURBO: 207-273W (without load)  
261W---Radish295W---Meat 202W---Eggs

63. Power test

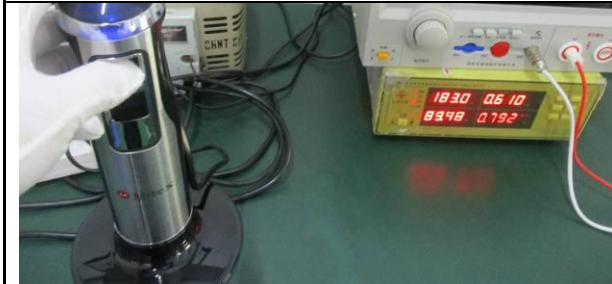
Sample Size : 5pieces  
Result : Passed

64. Low voltage start test

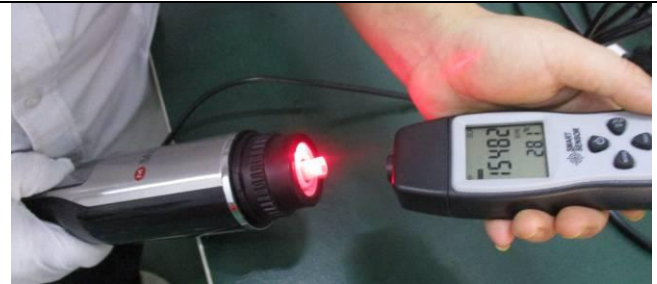
Sample Size : 5 pieces  
Result : Low: 9735-9855Rpm High: 14282-14435Rpm

Turbo: 15482-15832Rpm

65. Motor speed test

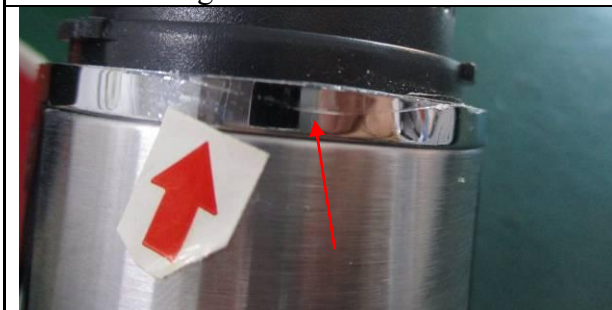
| Defective Descriptions | Critical | Major | Minor |
|---|---|---|---|
| - Scratched on decorative ring. | | | 1 |

66. Defect: Scratched on decorative ring

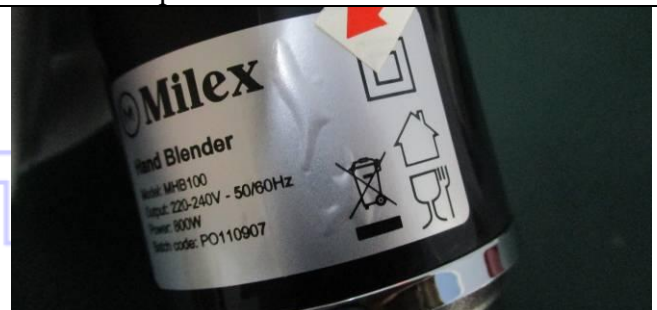
| Defective Descriptions | Critical | Major | Minor |
|---|---|---|---|
| - Air bubble on rating label. | | | 2 |

67. Defect: Air bubble on rating label

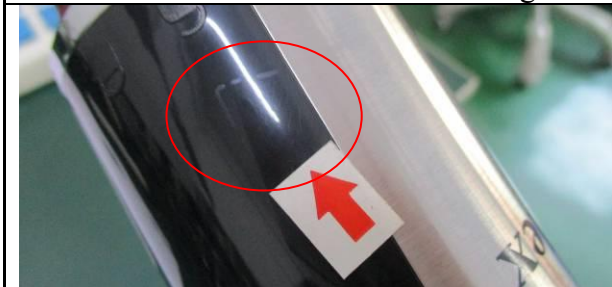
| Defective Descriptions | Critical | Major | Minor |
|---|---|---|---|
| - Scratched on unit. | | | 2 |

68. Defect: Scratched on unit

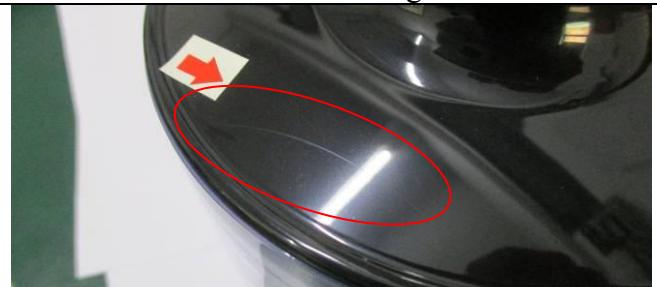
| Defective Descriptions | Critical | Major | Minor |
|---|---|---|---|
| - Scratched on lid. | | | 2 |

69. Defect: Scratched on lid

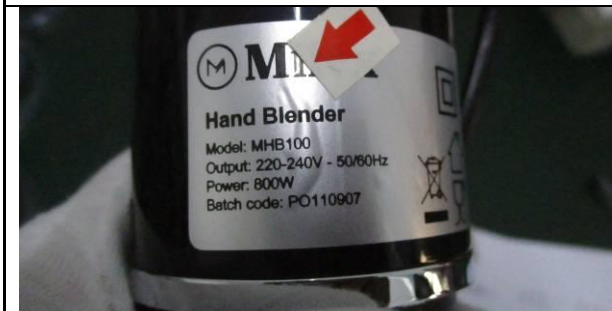
70. Air bubble on rating label

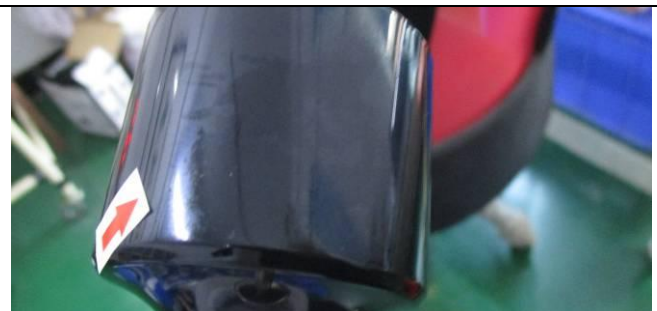
| Defective Descriptions | Critical | Major | Minor |
|---|---|---|---|
| - Oil on whisk holder. | | | 1 |

71. Defect: Oil on whisk holder

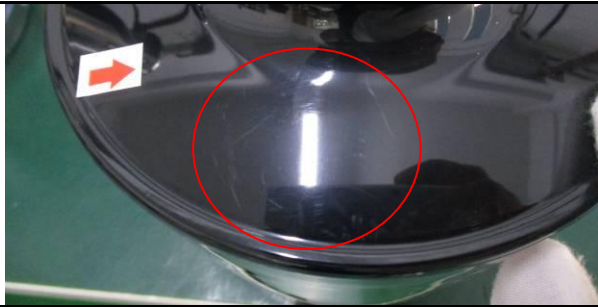
72. Defect: Scratched on lid

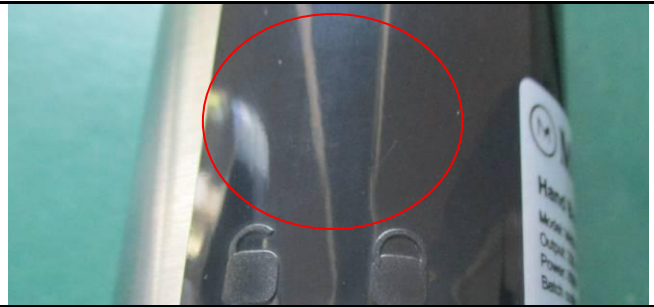
73. Defect: Scratched on unit
